AMERICAN AIRLINES, INC.
BOEING 727, N1996
NEAR THE GREATER CINCINNATI AIRPORT
CONSTANCE, KENTUCKY
NOVEMBER 8, 1965

CIVIL AERONAUTICS BOARD

AIRCRAFT ACCIDENT REPORT

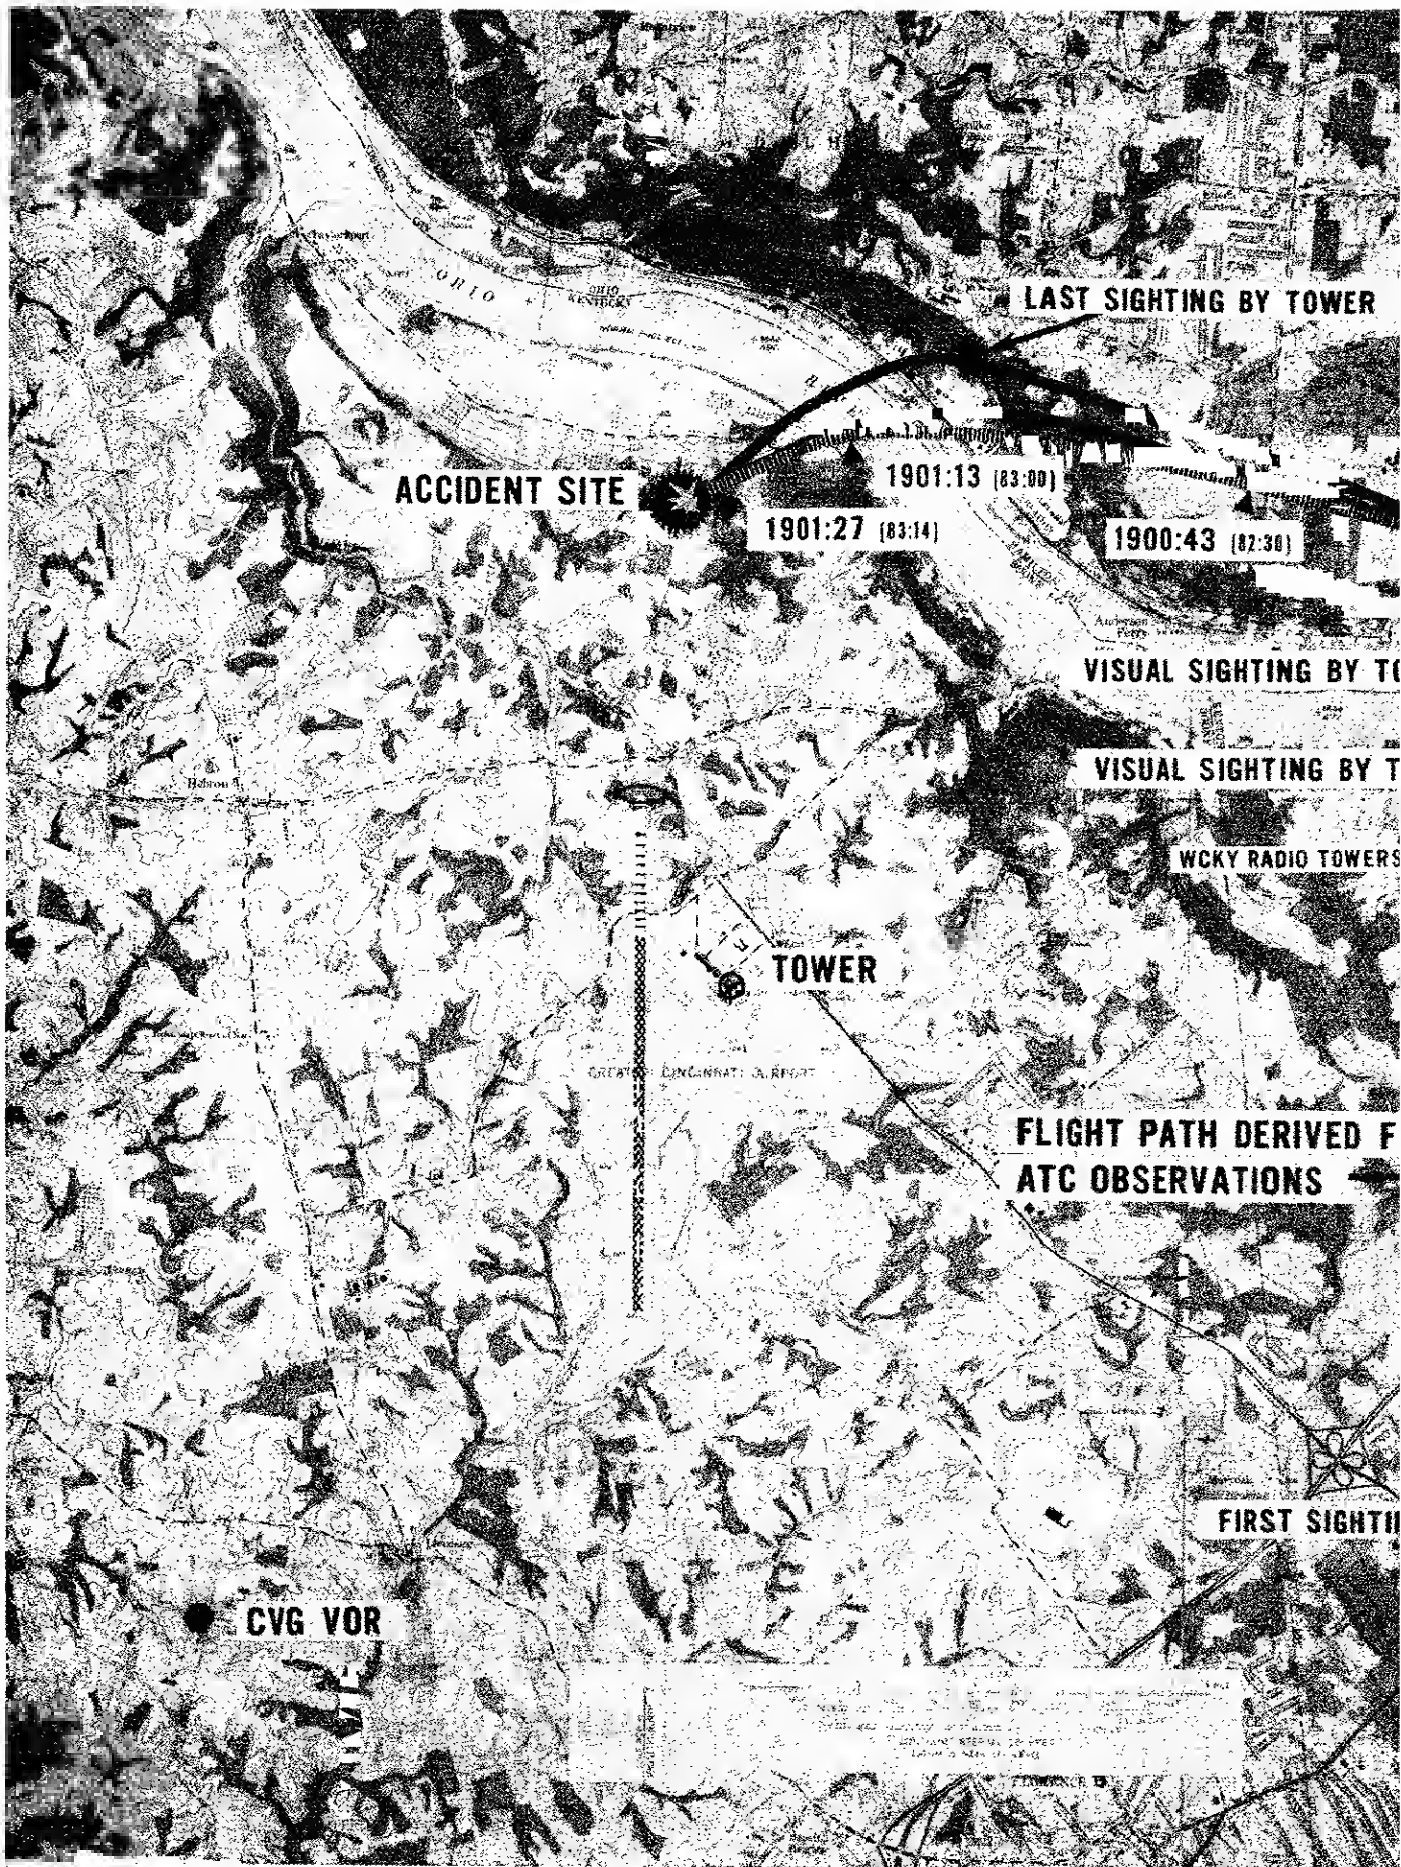
Federal Aviation Agency (FAA) tower personnel first observed the aircraft at a point approximately four miles east-southeast of the airport as it proceeded on the downwind leg in a northerly direction. (See Attachment #1.) It was stated that the aircraft's navigation lights were clearly visible and that the flight appeared to be operating at a normal traffic pattern altitude. One of the controllers stated that the aircraft passed about one mile to the east of the WCKY radio towers (located three miles east-northeast of the control tower), then commenced a left turn onto the base leg and started a gradual descent. The controller continued to watch the aircraft as it proceeded west on the base leg; however, at a point between two and three miles northeast of the airport it disappeared from his view. He stated that he believed the aircraft was lost from his view because it, "... appeared to fly into or behind weather phenomena."

A number of persons on the ground observed the aircraft during its approach. Their observations placed the aircraft approximately four miles east of the field on a northerly course while on the downwind leg. (See Attachment #1.) The flight was observed as it crossed the Ohio River and turned left to a westerly course. Witnesses stated that the aircraft had its navigation and landing lights on and that its altitude appeared to be low at this point.

It is noted that the particular terrain (see Attachment #1) in the vicinity of the aircraft's flightpath may well have provided the crew with an illusion of proper altitude or adequate terrain clearance. The Ohio River basin directly to the left of the flightpath is approximately 400 feet lower than the terrain directly under or to the right of the aircraft's flightpath. Also the terrain south of the river in the direction of the airport is featured by a wooded unlighted hillside which rises steeply from the river to the approximate elevation of the airport. Except for the lights of residences located near the riverbank there are no lights which would provide terrain definition. At night under poor visibility conditions it is quite conceivable that the elevation of the lights in the river valley could be associated with the elevation of the terrain in the vicinity of the airport.

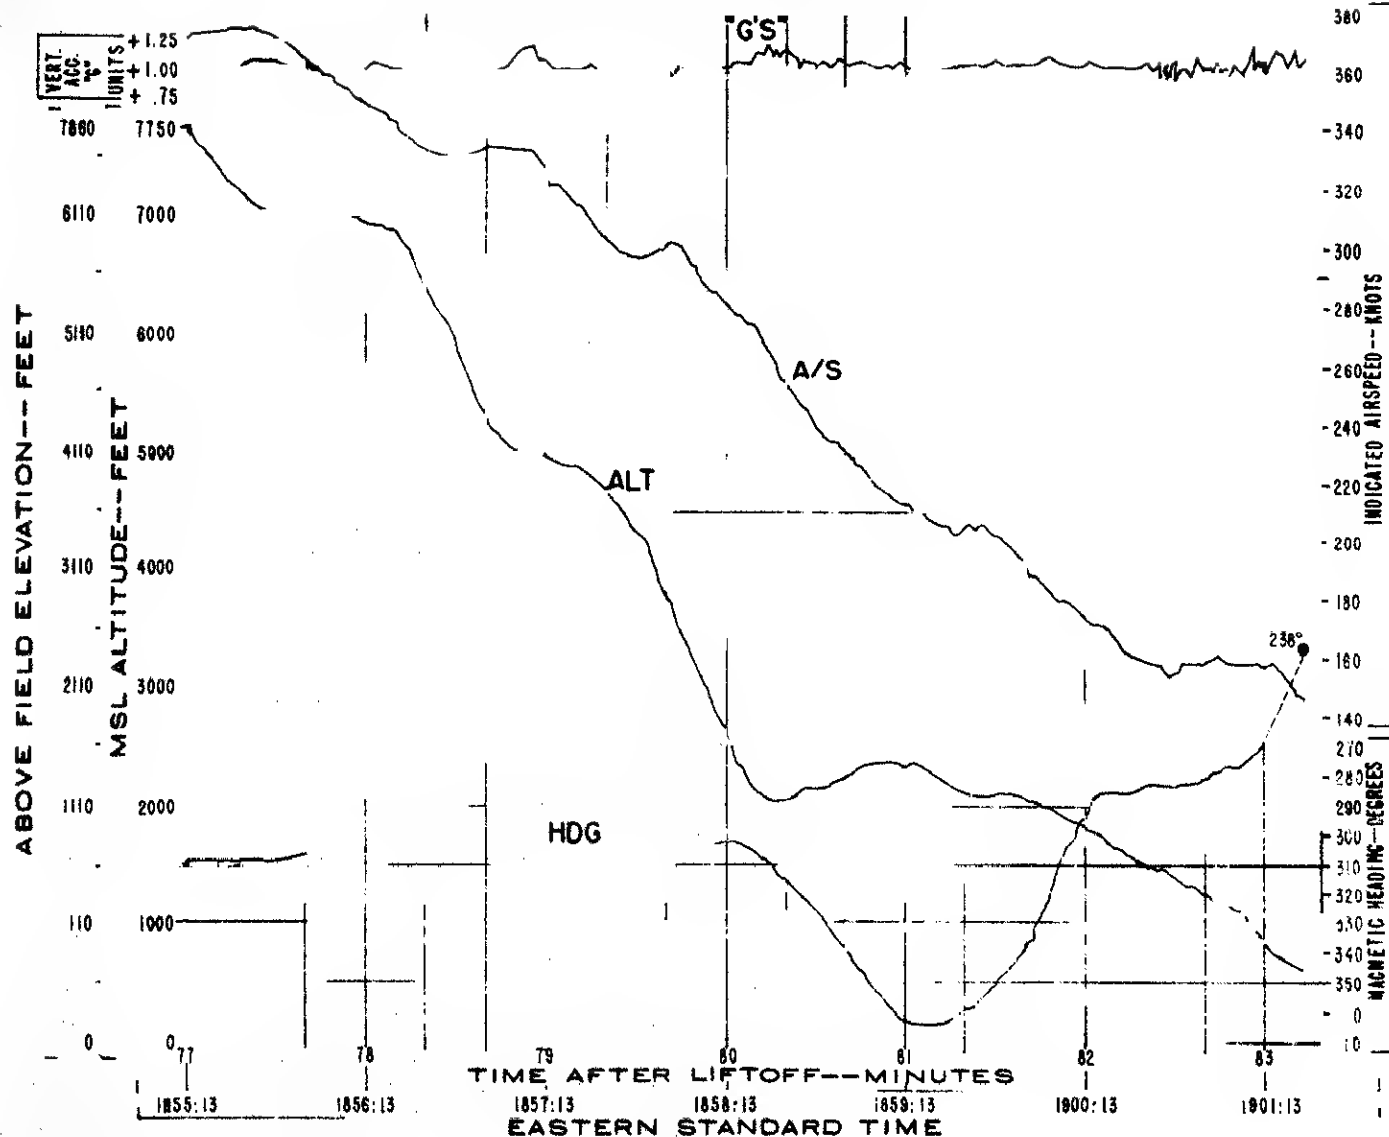
FLIGHT RECORDER DATA GRAPH
UDC MDEL F542 S/N 1395

The acceleration excursions noted throughout the readout were consistent with the maneuvers being performed and, except for the last 50 seconds of flight, no significant turbulence activity was noted. During the last 50 seconds of flight the G trace activity was suggestive of light turbulence computed to be less than 14 feet per second.

Note: Heading Parameter unreliable beyond 82.59 minutes due to aberrant area on tape except for data point at 83:14. Trace shows dotted between last readable points.

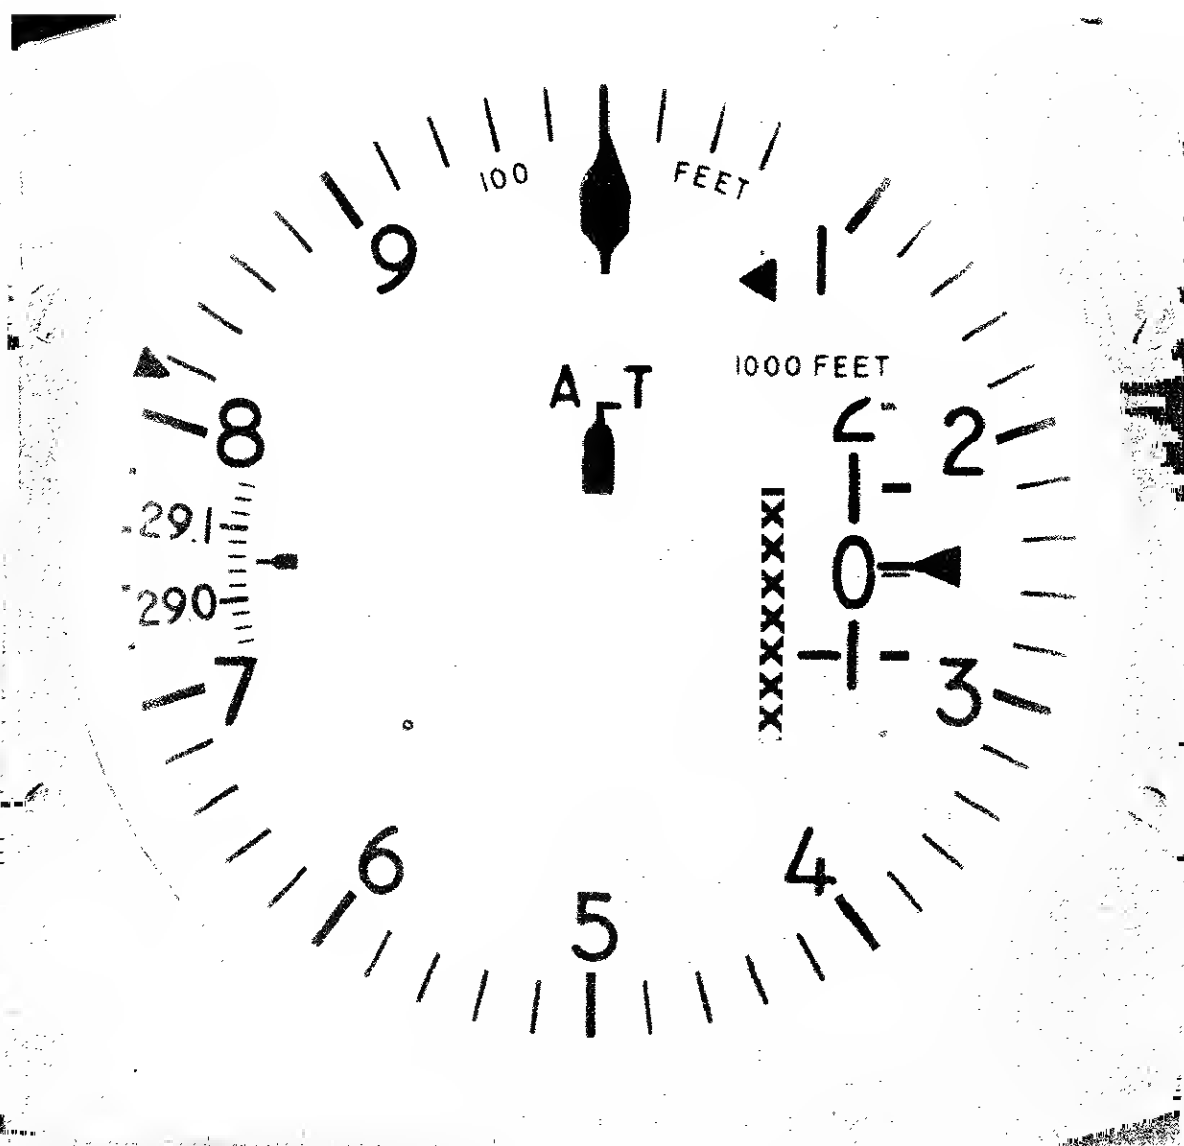
KOLLSMAN ALTIMETER

The three Kollsman altimeters^{9/} installed in the aircraft were recovered from the wreckage and were examined at the manufacturer's facility. The captain's (No. 1) altimeter was found at a barometric setting of 29.06 inches with the index marker set on 800 feet. A valid drum position could not be obtained because of internal mechanism disruption. The copilot's (No. 2) altimeter was found at a barometric scale setting of 29.03 inches with the index marker positioned at 815 feet. Only portions of the center instrument panel (No. 3) altimeter were recovered and no barometric, index marker, or drum position information could be obtained. A discussion of the American Airlines procedures for altimeter utilization and related procedures will be found in section 1.15 under the heading of AA altimeter procedures.

Examination of the pilot's and copilot's altimeters revealed no evidence of any pre-impact failure or malfunction and both were set properly to indicate altitude above field elevation. The functional capabilities of the No. 3 altimeter could not be determined because of extensive impact damage to this instrument. However, based on the fact that the last ATC clearance altitude of 2,000 feet m.s.l. was maintained for approximately two minutes on the downwind leg prior to the initiation of the descent, it is believed that this altimeter was properly set and functioning normally throughout the approach.

It is realized that in these cases or in any altitude presentation a pilot knowledgeable in the altimeter should have no problem whatsoever in quickly determining the correct altitude reading. However, it can also be seen that under certain conditions compounded by infrequent, fragmented, or distracted monitoring, a misreading/misinterpretation of altitude could occur.
